## **Characterising the level of crashworthiness for impacts on hard ground and water surfaces for a metallic helicopter under floor structure: What lessons can be learned?**

**K. Hughes**

Crashworthiness, Impact and Structural Mechanics Group (CISM),  
School of Engineering, Cranfield University, Cranfield, BEDS, MK43 0AL, UK

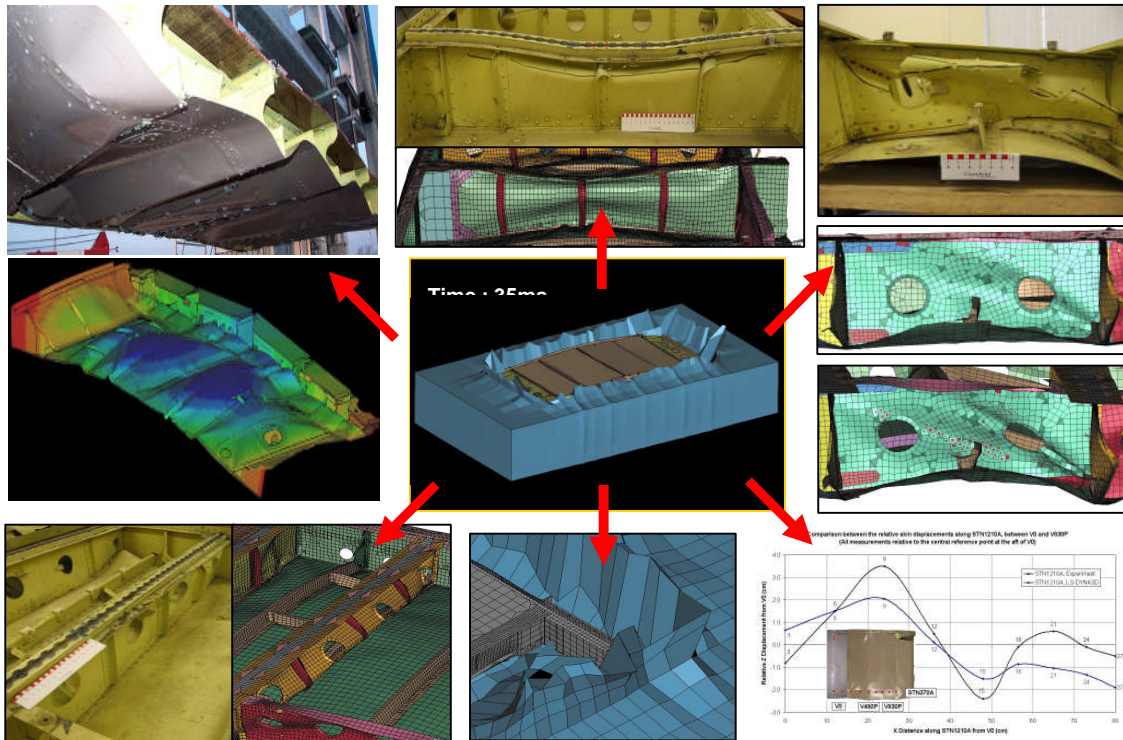
The post impact specimen can be found in figure 3, where the passenger floor has been removed for clarity. As can be seen, the floor retains its global integrity, as the main longitudinal frames remain undamaged, with the skin deflecting quite significantly in between these longitudinal frames. There are two main locations of skin and rivet failure, which would result in the ingress of water and the resulting secondary damage. The curved end sections remain relatively undamaged, as their shape minimises loading at these locations, due to the redirection of the water.

Figure 3 The finite element analysis allowed detailed comparisons with experiment for hinge location, skin deformation and collapsed height of the frames

To recreate numerically, a purely Lagrangian approach was used. The code was able to predict a representative response when compared to test, as good agreement for limited frame collapse, the deflections of the skin (within 10% of test), together with the locations of potential skin failure. Limited joint collapse is predicted, which is also consistent with test. The skin deflects in-between the frames, causing localised material and rivet failure, in the form of tensile pull-out from the surrounding frames.
